# INDOOR AIR QUALITY ASSESSMENT

## Marblehead High School 2 Humphrey Street Marblehead, Massachusetts

Prepared by:
Massachusetts Department of Public Health
Center for Environmental Health
Emergency Response/Indoor Air Quality Program
June 2005

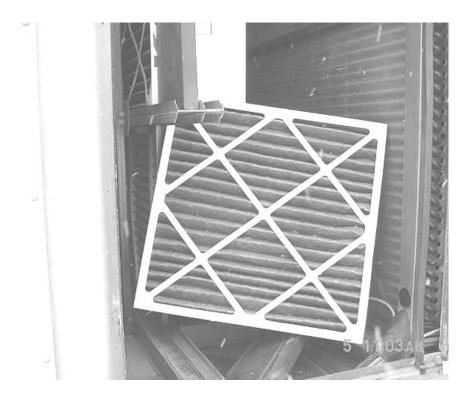
Mechanical ventilation is provided by rooftop air-handling units (AHUs) equipped with high efficiency pleated air filters (Pictures 1 and 2), which are reportedly changed up to five times a year (as needed). Fresh air is continuously distributed via

Rooftop Air Handling Unit Equipped With High Efficiency Pleated Air Filters

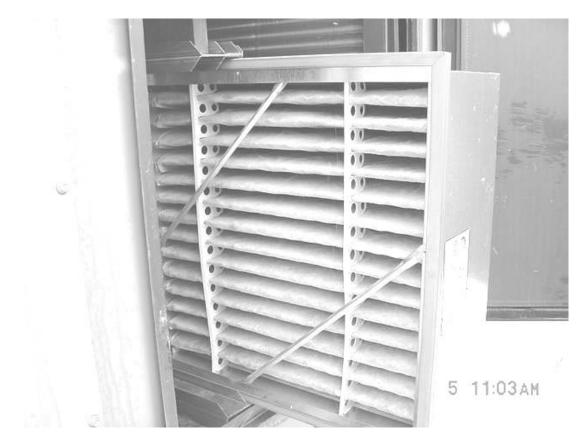
**Rooftop Air Handling Unit Equipped With Secondary Bag Filters**

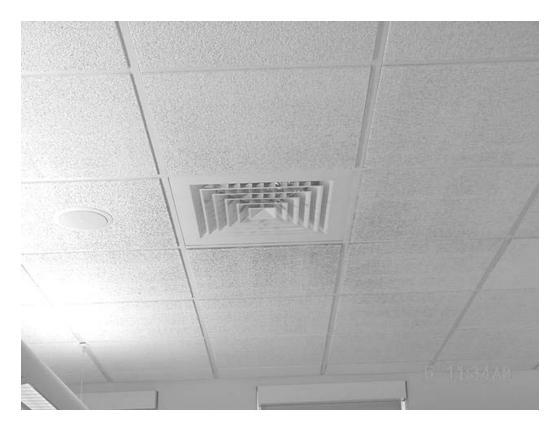
ceiling-mounted air diffusers and ducted back to AHUs via ceiling or wall-mounted return vents (Pictures 3 and 4). In some cases, the location of exhaust vents can limit exhaust efficiency. In several classrooms, exhaust vents are located above hallway doors (Picture 4). When classroom doors are open, exhaust vents will tend to draw air from both the hallway and the classroom reducing the effectiveness of the exhaust vent to remove common environmental pollutants.

Ceiling-Mounted Air Diffuser, Note Characteristic Dust Accumulation on Surrounding Tiles

- 12. Clean supply, return and exhaust vents periodically of accumulated dust.
  Attempts should also be made to clean dust accumulation on ceiling tiles adjacent to vents.

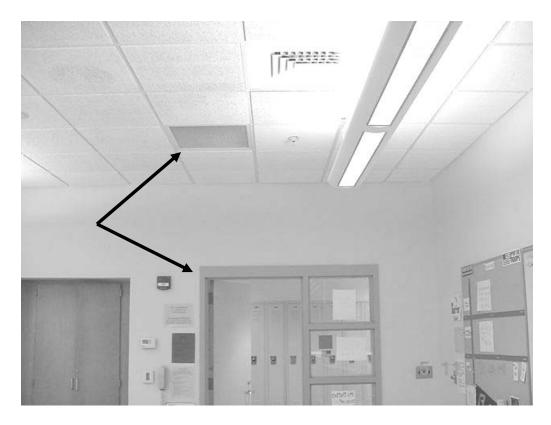
Ceiling-Mounted Return Vent, Note Proximity to Open Classroom Door

- Consider having the ventilation system balanced by an HVAC engineer every five years (SMACNA, 1994).
- 4. Close classroom doors to maximize air exchange.

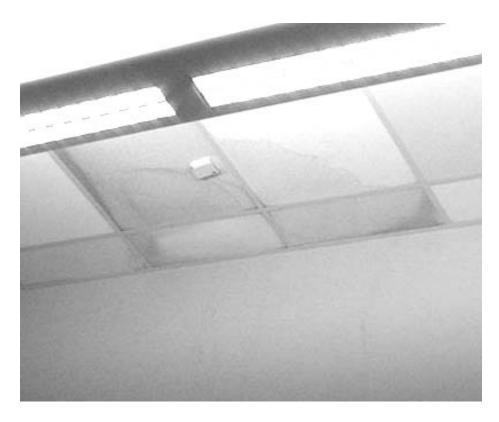
A number of areas throughout the building had water-damaged ceiling tiles, which can indicate leaks from the roof or plumbing system (Pictures 5 and 6). Water-damaged ceiling tiles can provide a source of mold and should be replaced after a water leak is discovered and repaired. No active leaks were reported by MHS staff or observed by MDPH staff during the assessment.

**Water Damaged Ceiling Tiles**

- 6. Ensure roof leaks are repaired and replace water damaged ceiling tiles. Examine the area above and around these areas for mold growth. Disinfect areas of water leaks with an appropriate antimicrobial.

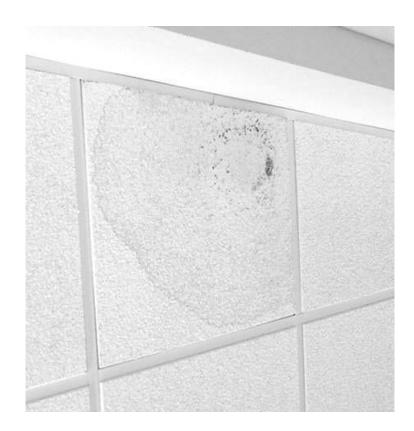
Water Damaged Ceiling Tiles, Note Dark Staining That May Indicate Mold Growth

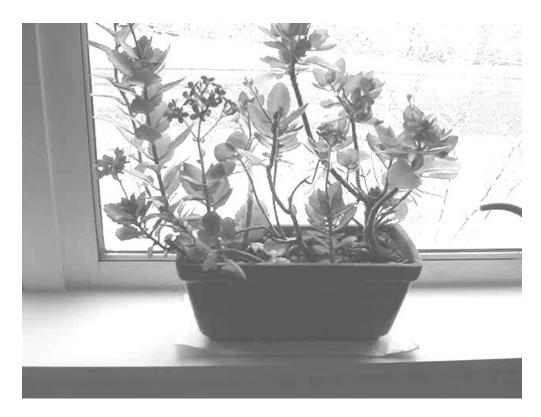
Several classrooms contained a number of plants (Picture 7). Plants, soil and drip pans can serve as sources of mold growth, and thus should be properly maintained. Plants should have drip pans to prevent wetting and subsequent mold colonization of window frames. Plants should also be located away from ventilation sources to prevent aerosolization of dirt, pollen or mold.

**Classroom Plant on Paper Towel**

- 7. Clean/maintain dehumidifiers/humidifiers as per the manufactures' instructions.
- 8. Ensure all plants are equipped with drip pans. Examine drip pans periodically for mold growth and disinfect with an appropriate antimicrobial where necessary.

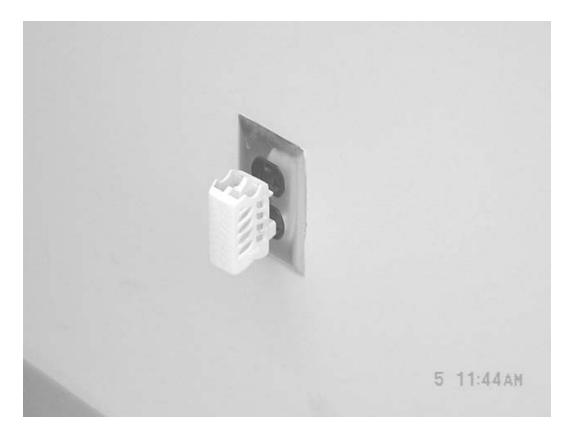
Chemical odors were detected in room B-305. The source of the odor was a plugin air freshener (Picture 8). Air fresheners contain chemicals that can be irritating to the eyes, nose and throat of sensitive individuals. In addition, air fresheners do not remove materials causing odors, but rather mask odors, which may be present in the area.

Plug-In Air Freshener in Classroom

- 13. Vent clothes dryer to the outside.
- 14. Refrain from using strongly scented materials (e.g., air fresheners) in classrooms.
- 15. Clean/change filters for portable air purifiers as per the manufactures' instructions.

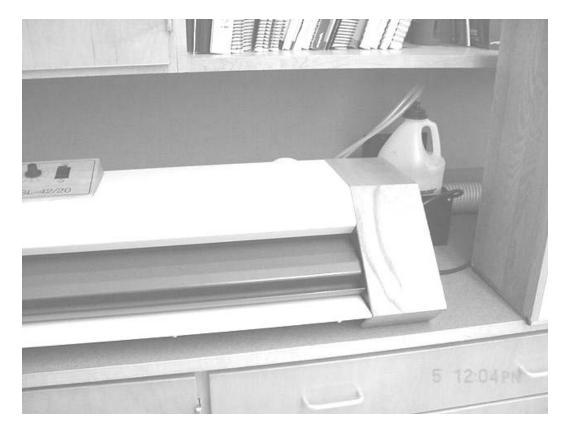
Classroom B-213 contained a blueprint machine/printer (Picture 9). Blueprint machines use ammonia and can give off VOCs and irritating odors during use. This area is not equipped with a local mechanical exhaust system that would remove off-gassing vapors generated during the operation of this machine.

**Ammonia-Based Blueprint Machine**

- 10. Consider discontinuing use of the blueprint machine, installing local exhaust ventilation or relocating to an area equipped with local exhaust ventilation.

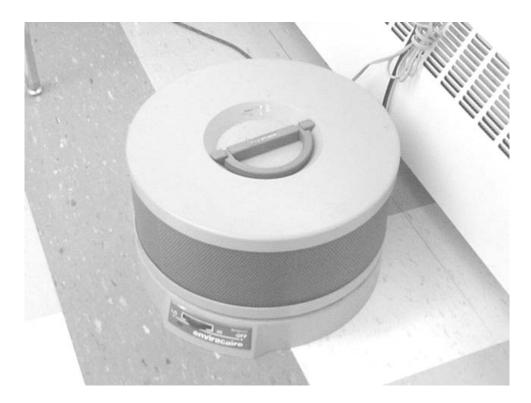
A number of rooms had portable air purifiers (Picture 10). This equipment has air filters that should be cleaned or changed as per the manufactures' instructions to avoid the reaerosolization of dusts and particulates. Items were also observed hanging from ceiling tiles. The movement or damage to ceiling tiles can release accumulated dirt, dust and particulates that accumulate in the ceiling plenum into occupied areas.

**Portable Air Purifier on Floor**
